Case Illustration

IlluminOss Used in Conjunction with a Plate in the Treatment of a Humerus Nonunion

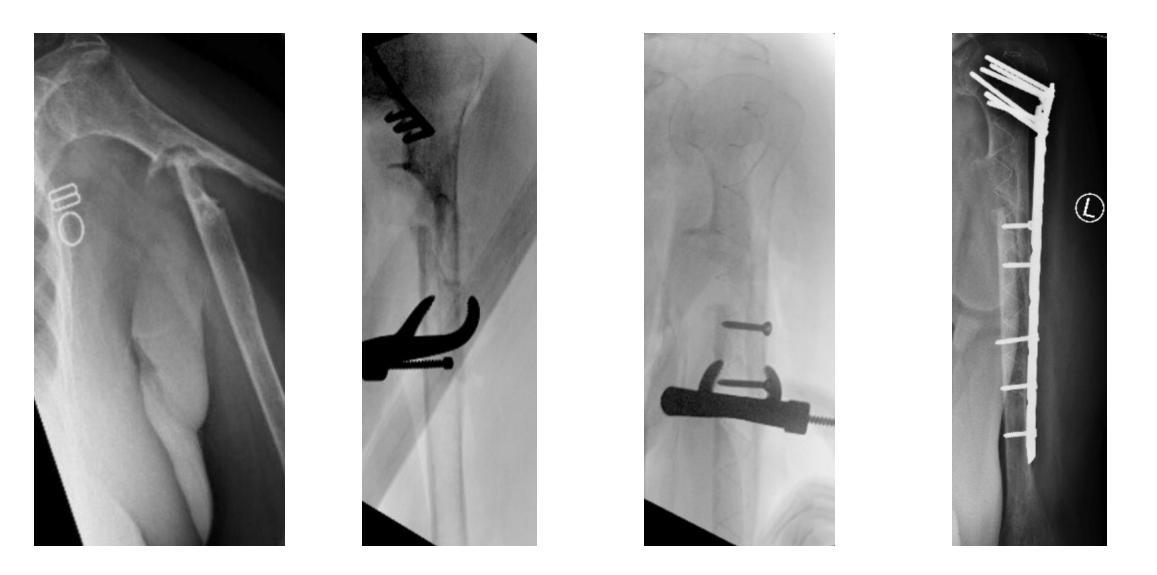
An 82-year-old female sustained a humerus fracture after a ground level fall and was seen by another physician who recommended closed treatment. Past medical history was significant for hypertension, high BMI, poor bone quality and lymph node dissection on the injured arm. Several months later, she presented with pseudoarthrosis and loss of mobility. The patient was treated operatively, reducing the pseudoarthrosis through open reduction. A small incision was made, an IlluminOss implant was inserted, filled with liquid monomer, and cured with visible light. Lag screws were then placed through the IlluminOss, and the distal fragments and a bypassing plate was placed over the humeral shaft. At 6 weeks post-op the patient reported no pain with good range of motion in her arm.
